# Apple TV 3rd Generation Snap-on Base Replacement

How to easily replace this important part on you device

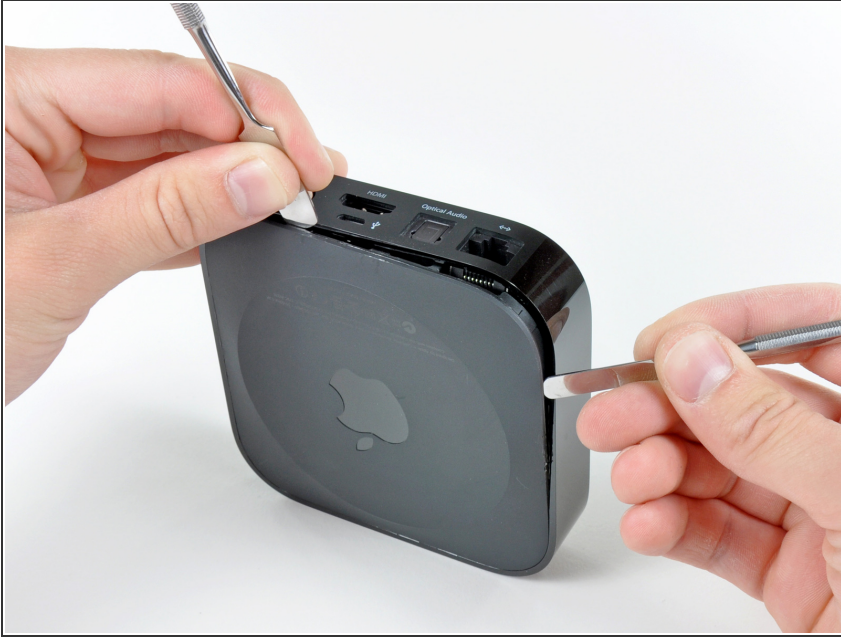
## Step 1 — Snap-on Base

- As the device base is firmly clipped, insert two metal spudgers to gently release the first clips.

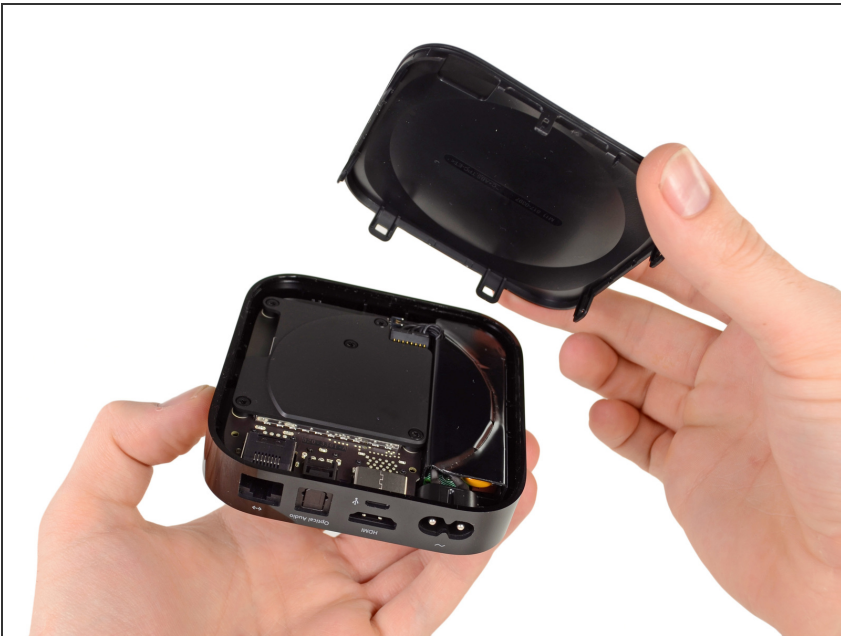
## Step 2

- Continue releasing the last plastic clips with your hands caring not to broke any of the plastic elements attached to the base.

To reassemble your device, follow these instructions in reverse order.
